# **Madeira Community Development District**

**Board of Supervisors' Meeting  
February 22, 2023**

**Waterways:** Twelve ponds

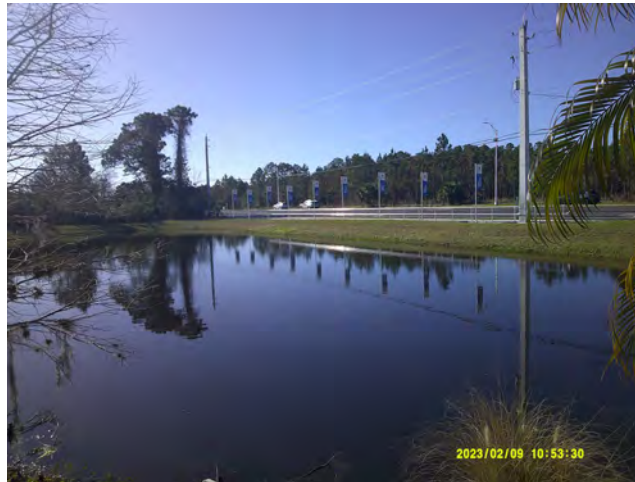
**Pond 1:** Pond was in good condition. Water level and clarity were normal. No trash or algae noticed.

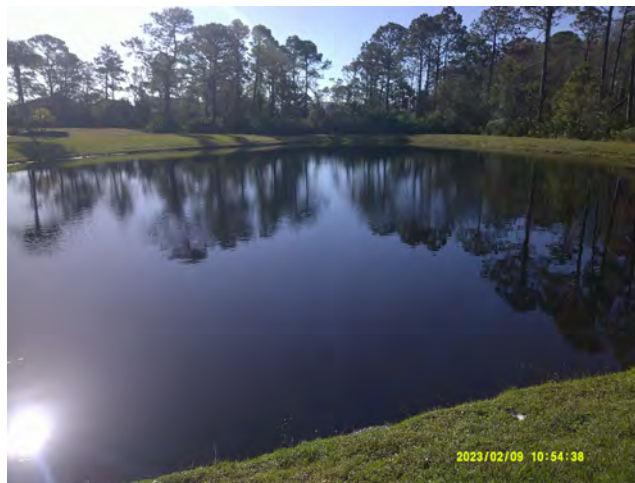
**Pond 2:** Pond was in good condition. Water level and clarity were good. No algae or trash noticed.

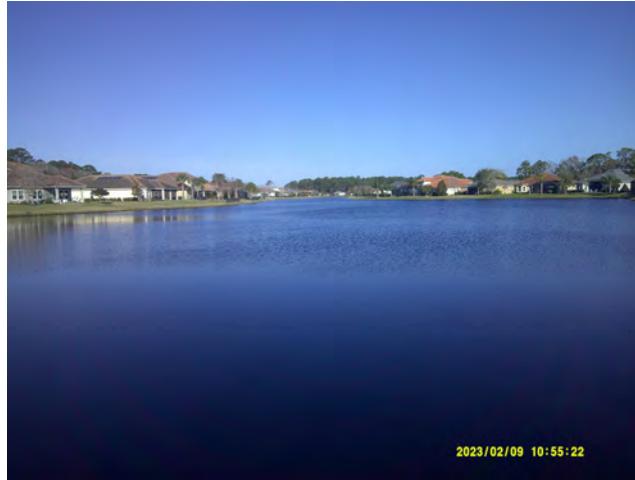
**Pond 3:** Pond was in good condition. Water level and clarity were normal. No algae or trash noticed. Checked outflow structure.

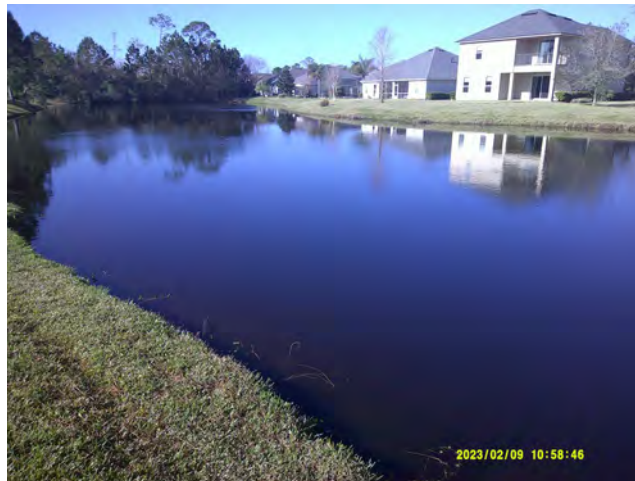
**Pond 4:** Pond was in good condition. Water level and clarity were normal. No algae or trash noticed.

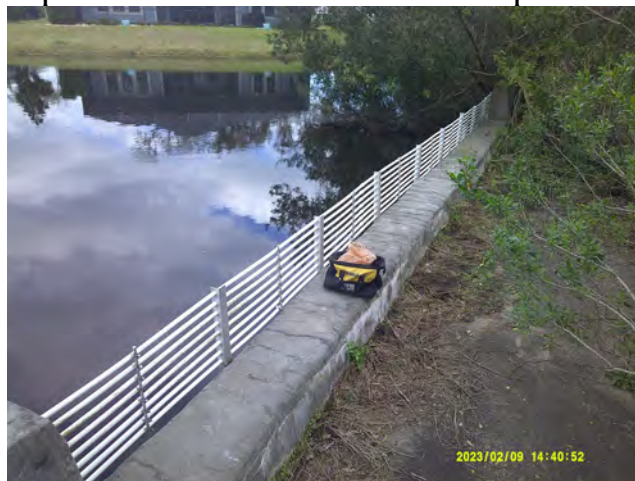
**Pond 5:** Pond was in good condition. No algae or trash noticed. Water level and clarity were normal. Updated barrier to meet FWC inspector recommendations.

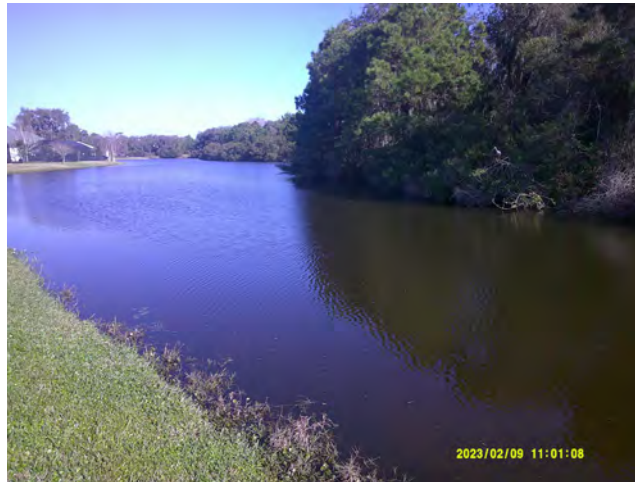
**Pond 6:** Pond was in good condition. Water level and clarity were normal. No algae or trash noticed.

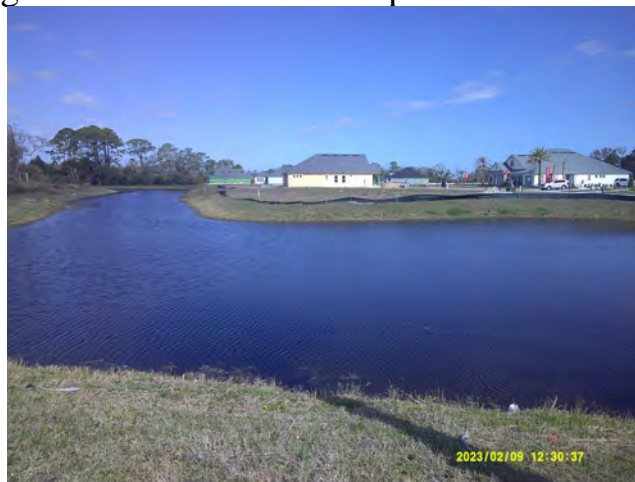
**Pond 7:** Pond was in good condition. Water level and clarity were normal. No algae or invasive vegetation noticed. Picked up trash.

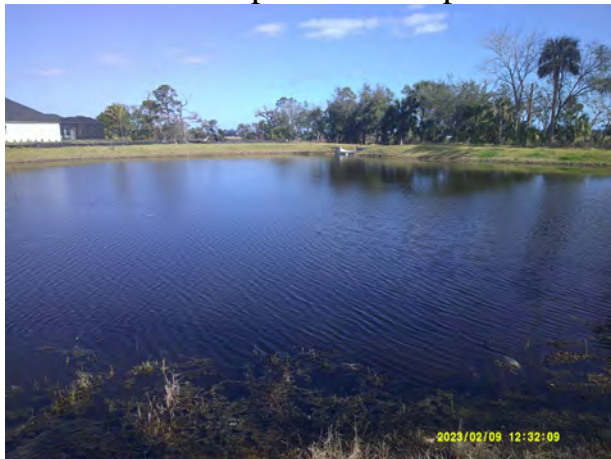
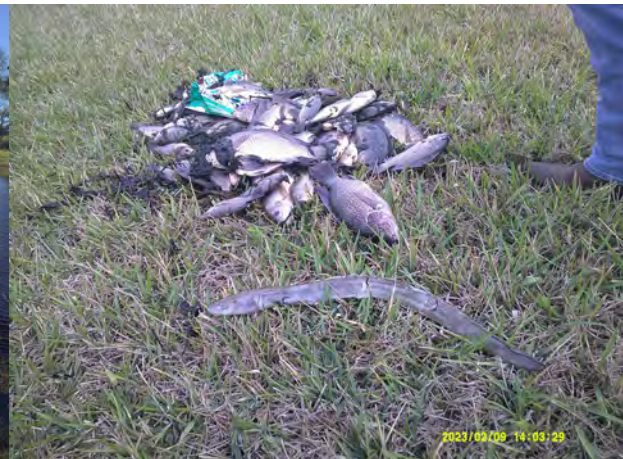
**Pond 8:** Pond was in good condition. Water level and clarity were good. Picked up a lot of dead Tilapia from the pond. Checked outflow structure.

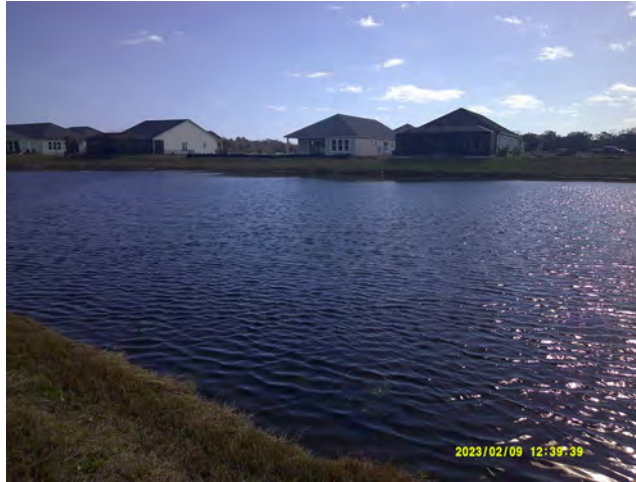
**Pond 9:** Pond was in good condition. Water level and clarity were good. No algae or invasive vegetation noted.

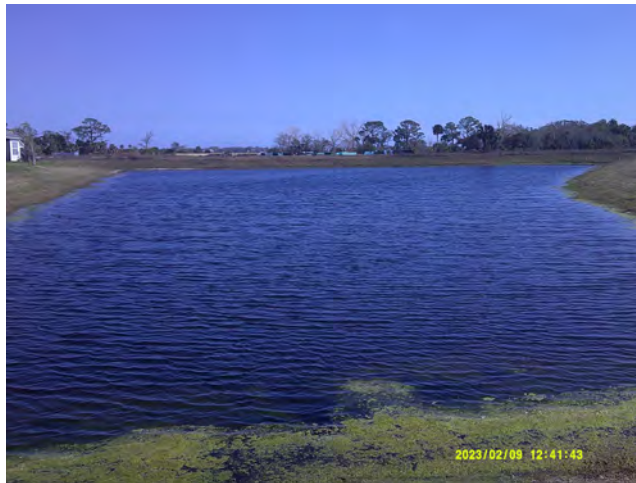
**Pond 10:** Pond was in good condition. Water level and clarity were good. No invasive vegetation noticed.

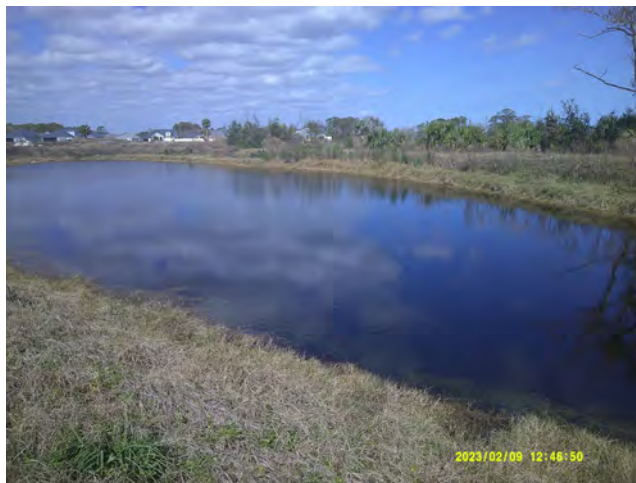
**Pond 11:** Pond was in good condition. Water level and clarity were normal. No trash noticed. Checked outflow structure.

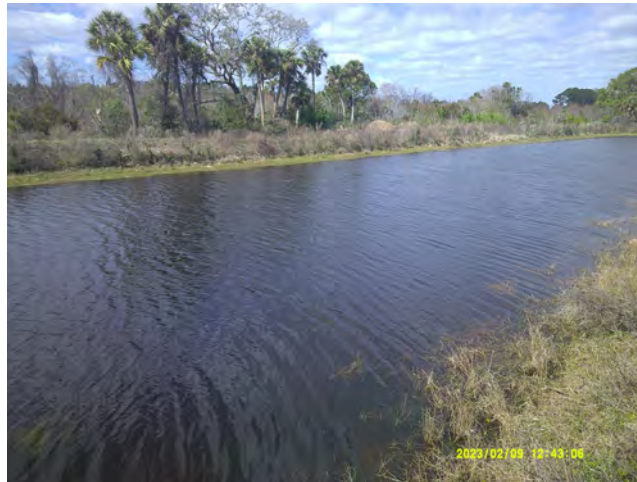
**Pond 12:** Pond was in good condition. Water level and clarity were good. Checked the outflow structure.

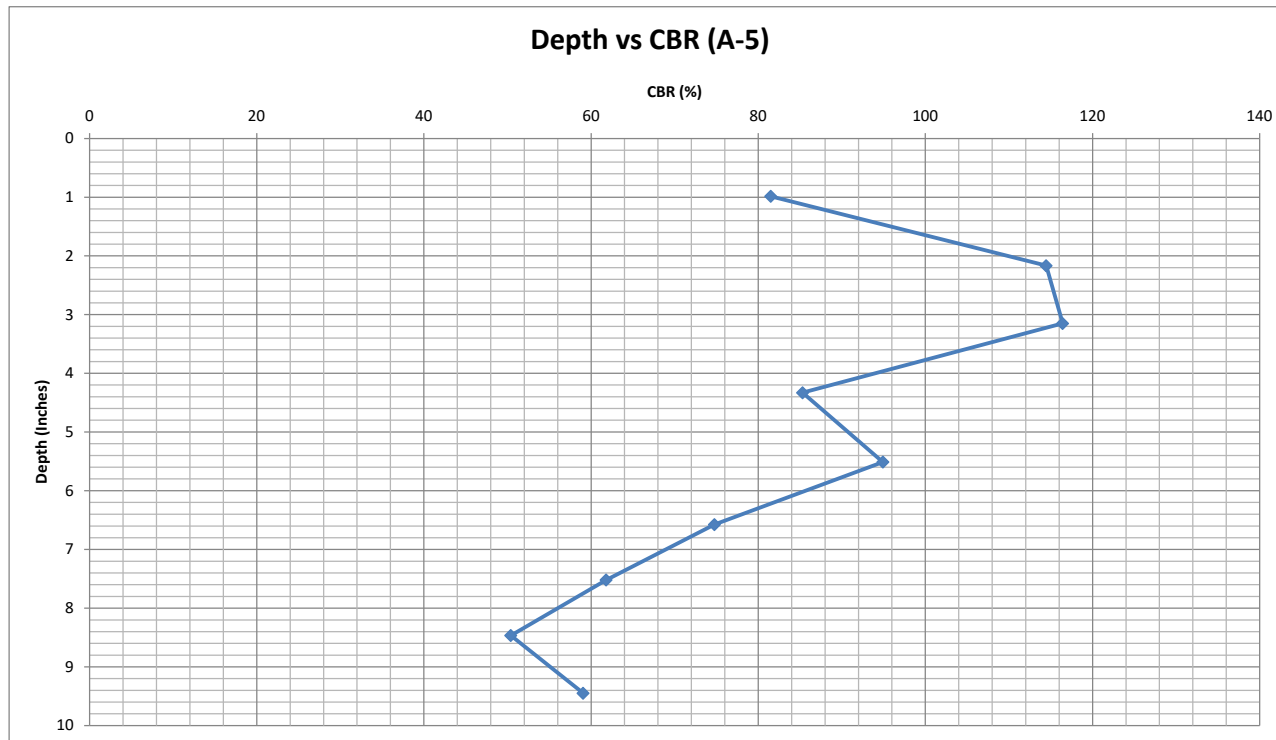
Project:	Madeira
Date:	9/15/2022
Location:	A-5
Hammer Weight (kg):	8

No. of Blows	Accumulative Penetration (mm)	Incremental Penetration (in)	Penetration per Blow Set (mm)	Penetration per Blow (mm)	Hammer Blow Factor	CBR (%)	LBR (%)
0	395	0.0	0	-	-	-	-
8	420	1.0	25	3.1	1	81.5	97.8
13	450	2.2	30	2.3	1	114.5	137.3
11	475	3.1	25	2.3	1	116.4	139.7
10	505	4.3	30	3.0	1	85.3	102.4
11	535	5.5	30	2.7	1	94.9	113.9
8	562	6.6	27	3.4	1	74.8	89.7
6	586	7.5	24	4.0	1	61.8	74.2
5	610	8.5	24	4.8	1	50.4	60.5
6	635	9.4	25	4.2	1	59.0	70.9

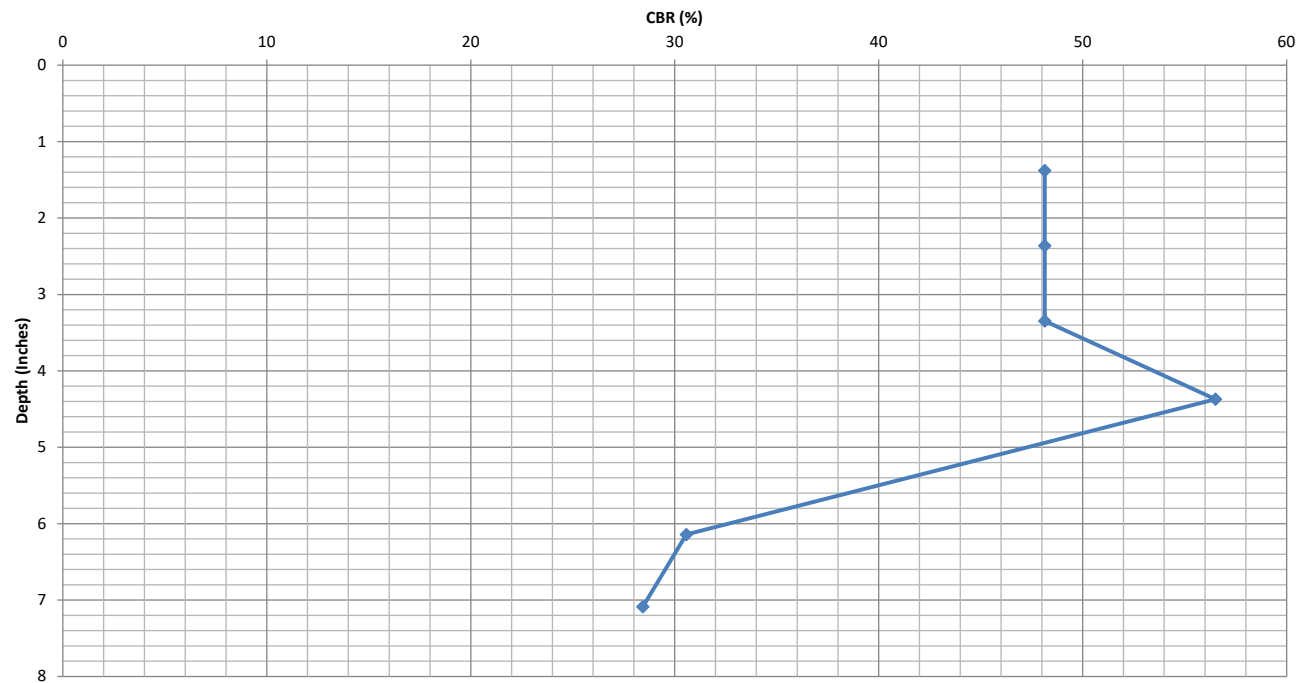
**Depth vs CBR (A-6)**

No. of Blows	Accumulative Penetration (mm)	Incremental Penetration (in)	Penetration per Blow Set (mm)	Penetration per Blow (mm)	Hammer Blow Factor	CBR (%)	LBR (%)
0	395	0.0	0	-	-	-	-
7	430	1.4	35	5.0	1	48.1	57.8
5	455	2.4	25	5.0	1	48.1	57.8
5	480	3.3	25	5.0	1	48.1	57.8
6	506	4.4	26	4.3	1	56.5	67.8
6	551	6.1	45	7.5	1	30.6	36.7
3	575	7.1	24	8.0	1	28.4	34.1

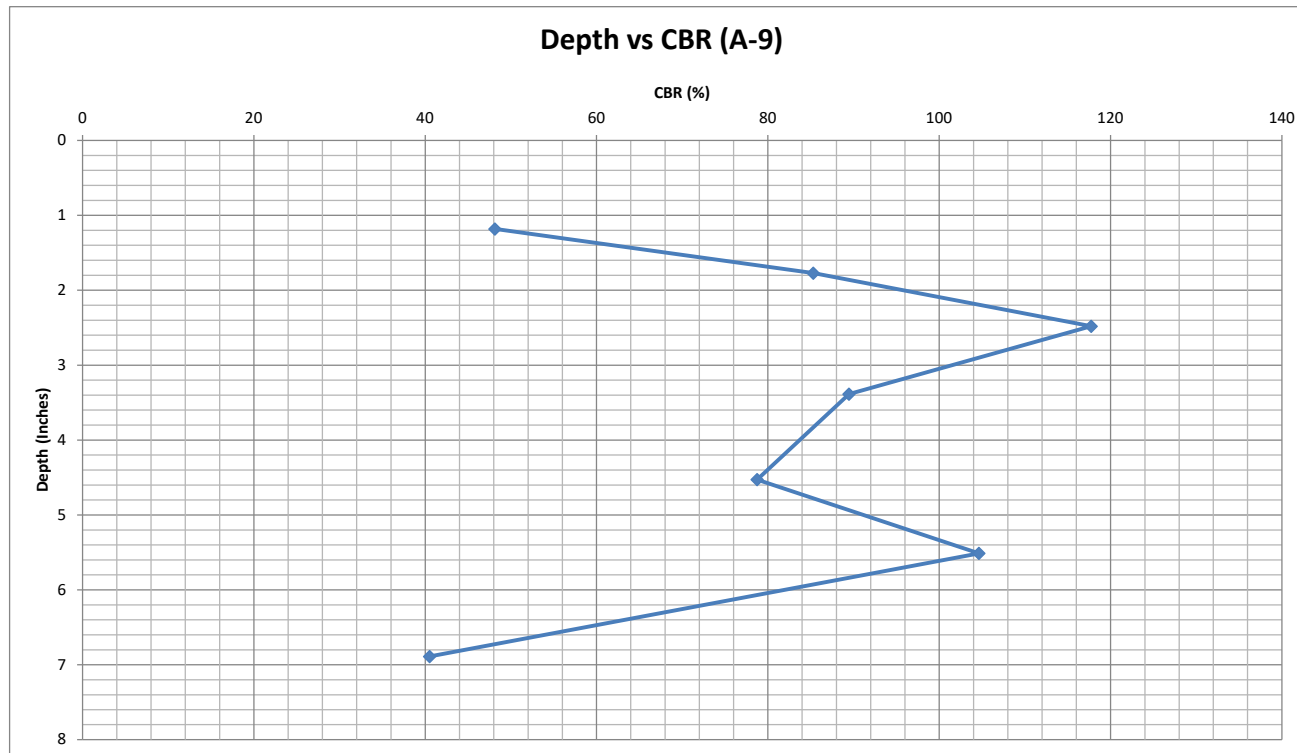
Project:	Madeira
Date:	9/15/2022
Location:	A-9
Hammer Weight (kg):	8

No. of Blows	Accumulative Penetration (mm)	Incremental Penetration (in)	Penetration per Blow Set (mm)	Penetration per Blow (mm)	Hammer Blow Factor	CBR (%)	LBR (%)
0	385	0.0	0	-	-	-	-
6	415	1.2	30	5.0	1	48.1	57.8
5	430	1.8	15	3.0	1	85.3	102.4
8	448	2.5	18	2.3	1	117.7	141.3
8	471	3.4	23	2.9	1	89.5	107.4
9	500	4.5	29	3.2	1	78.7	94.5
10	525	5.5	25	2.5	1	104.6	125.6
6	560	6.9	35	5.8	1	40.5	48.6

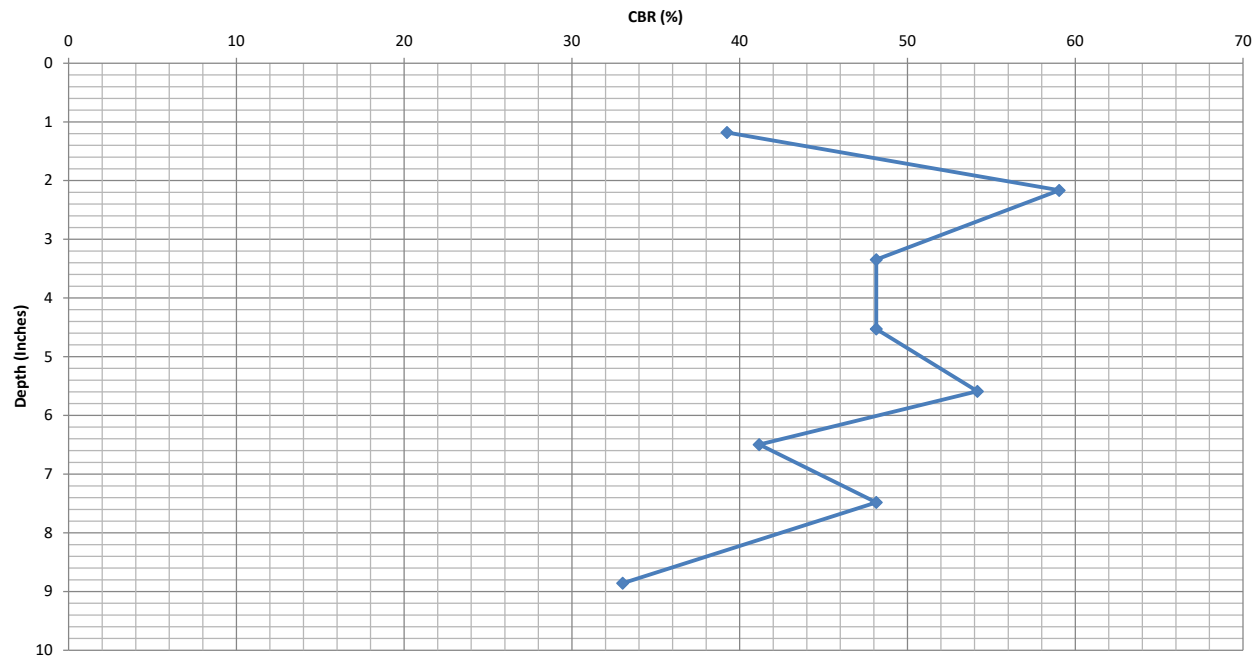
**Depth vs CBR (A-12)**

No. of Blows	Accumulative Penetration (mm)	Incremental Penetration (in)	Penetration per Blow Set (mm)	Penetration per Blow (mm)	Hammer Blow Factor	CBR (%)	LBR (%)
0	380	0.0	0	-	-	-	-
5	410	1.2	30	6.0	1	39.3	47.1
6	435	2.2	25	4.2	1	59.0	70.9
6	465	3.3	30	5.0	1	48.1	57.8
6	495	4.5	30	5.0	1	48.1	57.8
6	522	5.6	27	4.5	1	54.2	65.0
4	545	6.5	23	5.8	1	41.2	49.4
5	570	7.5	25	5.0	1	48.1	57.8
5	605	8.9	35	7.0	1	33.0	39.6
